Technical Service Bulletin

NUMBER: 09-05-00

Spark Knock And Engine Oil Consumption Due To Intake Manifold Pan Gasket Oil Leak

This bulletin involves the replacement of the engine intake manifold plenum pan gasket.

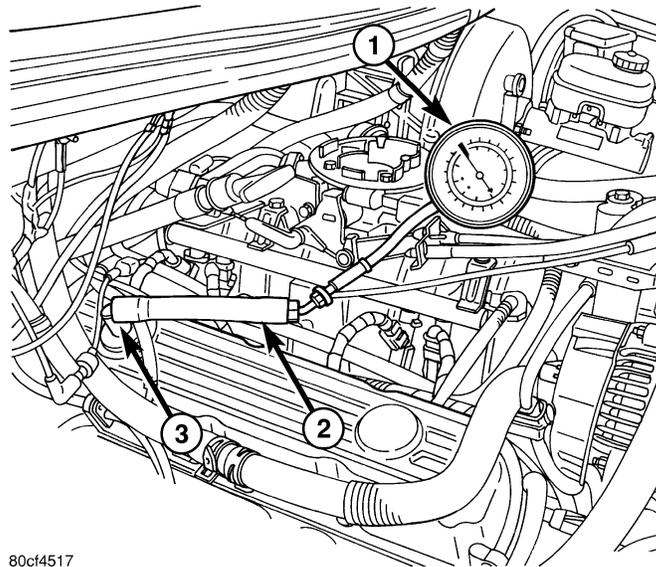
FIGURE 1

- 1 – VACUUM / PRESSURE GAUGE
2 – BREATHER HOSE
3 – VALVE COVER BREATHER HOSE PORT

1. Allow the engine to reach normal operating temperature.
2. Stop the engine.
3. Disconnect the breather hose from the air cleaner.
4. Attach a vacuum / pressure gauge to the end of the breather hose (Figure 1).

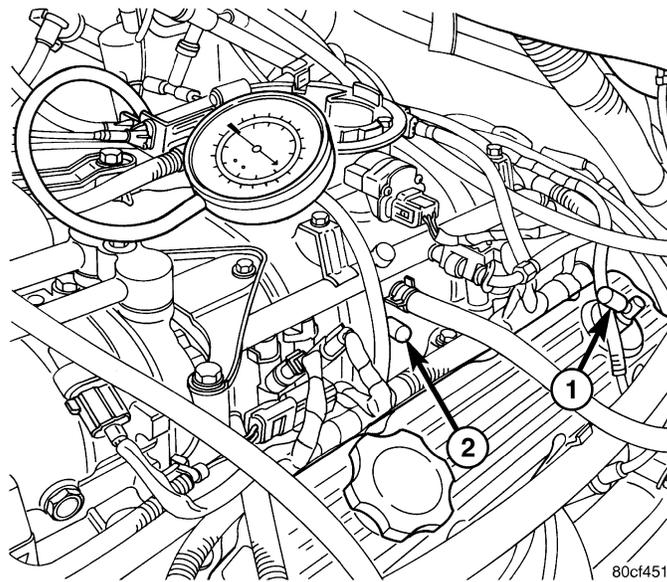
FIGURE 2

- 1 – CAPPED OFF PCV VALVE
- 2 – CAPPED OFF INTAKE MANIFOLD PCV PORT

5. Disconnect the PCV valve hose from the intake manifold.
6. Seal off the intake manifold PCV valve hose port opening.
7. Seal off the open end of the PCV valve hose (Figure 2).

8. Start the warmed engine and observe the vacuum gauge.
9. Allow the engine to idle for approximately 30 seconds. Do not allow more than 3 psi (20.7 kPa) of pressure to develop in the engine crankcase.
10. If the attached vacuum / pressure gauge does not indicate that a vacuum is present in the engine crankcase, then the intake manifold plenum pan gasket is good and no further internal engine vacuum leak diagnosis is required.

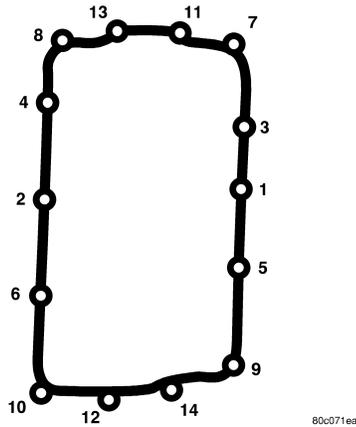
FIGURE 3

3.9L Intake Plenum Pan Bolt Tightening Sequence

3.9L Plenum Pan Bolt Torque Procedure

STEP	WHICH BOLT	TORQUE
1	All Bolts	5.4 Nm (48 in. lbs.)
2	All Bolts	9.5 Nm (84 in. lbs.)
3	Check All Bolts	9.5 Nm (84 in. lbs.)

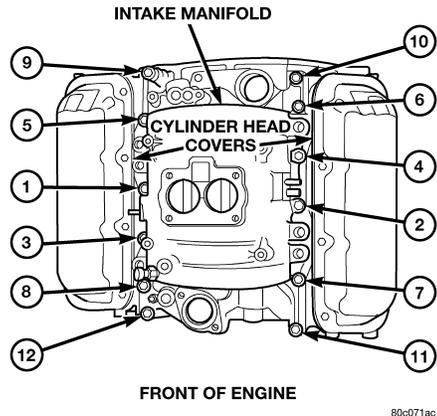
FIGURE 4

3.9L Intake Manifold Bolt Tightening Sequence

3.9L Intake Manifold Flange Bolt Torque Procedure

STEP	WHICH BOLT	TORQUE
1	1 and 2	1.4 Nm (12 in. lbs.)
2	1 and 2	2.7 Nm (24 in. lbs.)
3	1 and 2	4.1 Nm (36 in. lbs.)
4	1 and 2	5.4 Nm (48 in. lbs.)
5	1 and 2	6.7 Nm (60 in. lbs.)
6	1 and 2	8.1 Nm (72 in. lbs.)
7	3 through 12	8.1 Nm (72 in. lbs.)
8	Check All Bolts	8.1 Nm (72 in. lbs.)
9	All Bolts	16.3 Nm (12 ft. lbs.)
10	Check All Bolts	16.3 Nm (12 ft. lbs.)

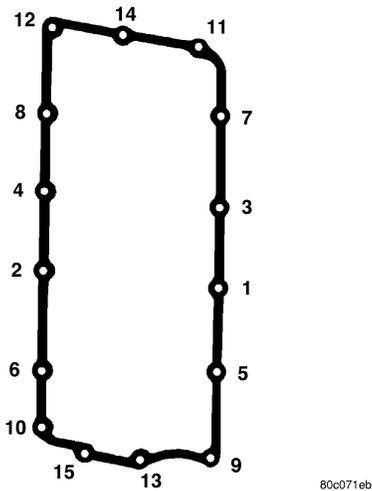
FIGURE 5

5.2L / 5.9L Intake Plenum Pan Bolt Tightening Sequence

5.2L / 5.9L Plenum Pan Bolt Torque Procedure

STEP	WHICH BOLT	TORQUE
1	All Bolts	5.4 Nm (48 in. lbs.)
2	All Bolts	9.5 Nm (84 in. lbs.)
3	Check All Bolts	9.5 Nm (84 in. lbs.)

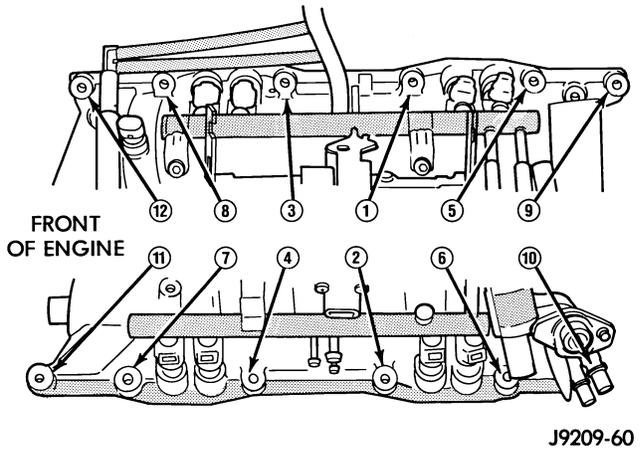
FIGURE 6

5.2L / 5.9L Intake Manifold Bolt Tightening Sequence

5.2L / 5.9L Intake Manifold Flange Bolt Torque Procedure

STEP	WHICH BOLT	TORQUE
1	1 and 4	1.4 Nm (12 in. lbs.)
2	1 and 4	2.7 Nm (24 in. lbs.)
3	1 and 4	4.1 Nm (36 in. lbs.)
4	1 and 4	5.4 Nm (48 in. lbs.)
5	1 and 4	6.7 Nm (60 in. lbs.)
6	1 and 4	8.1 Nm (72 in. lbs.)
7	5 through 12	8.1 Nm (72 in. lbs.)
8	Check All Bolts	8.1 Nm (72 in. lbs.)
9	All Bolts	16.3 Nm (12 ft. lbs.)
10	Check All Bolts	16.3 Nm (12 ft. lbs.)
